NATIONAL TRANSPORTATION SAFETY BOARD

Group Chairman's Factual Report

AIR TRAFFIC CONTROL

ANC13FA030

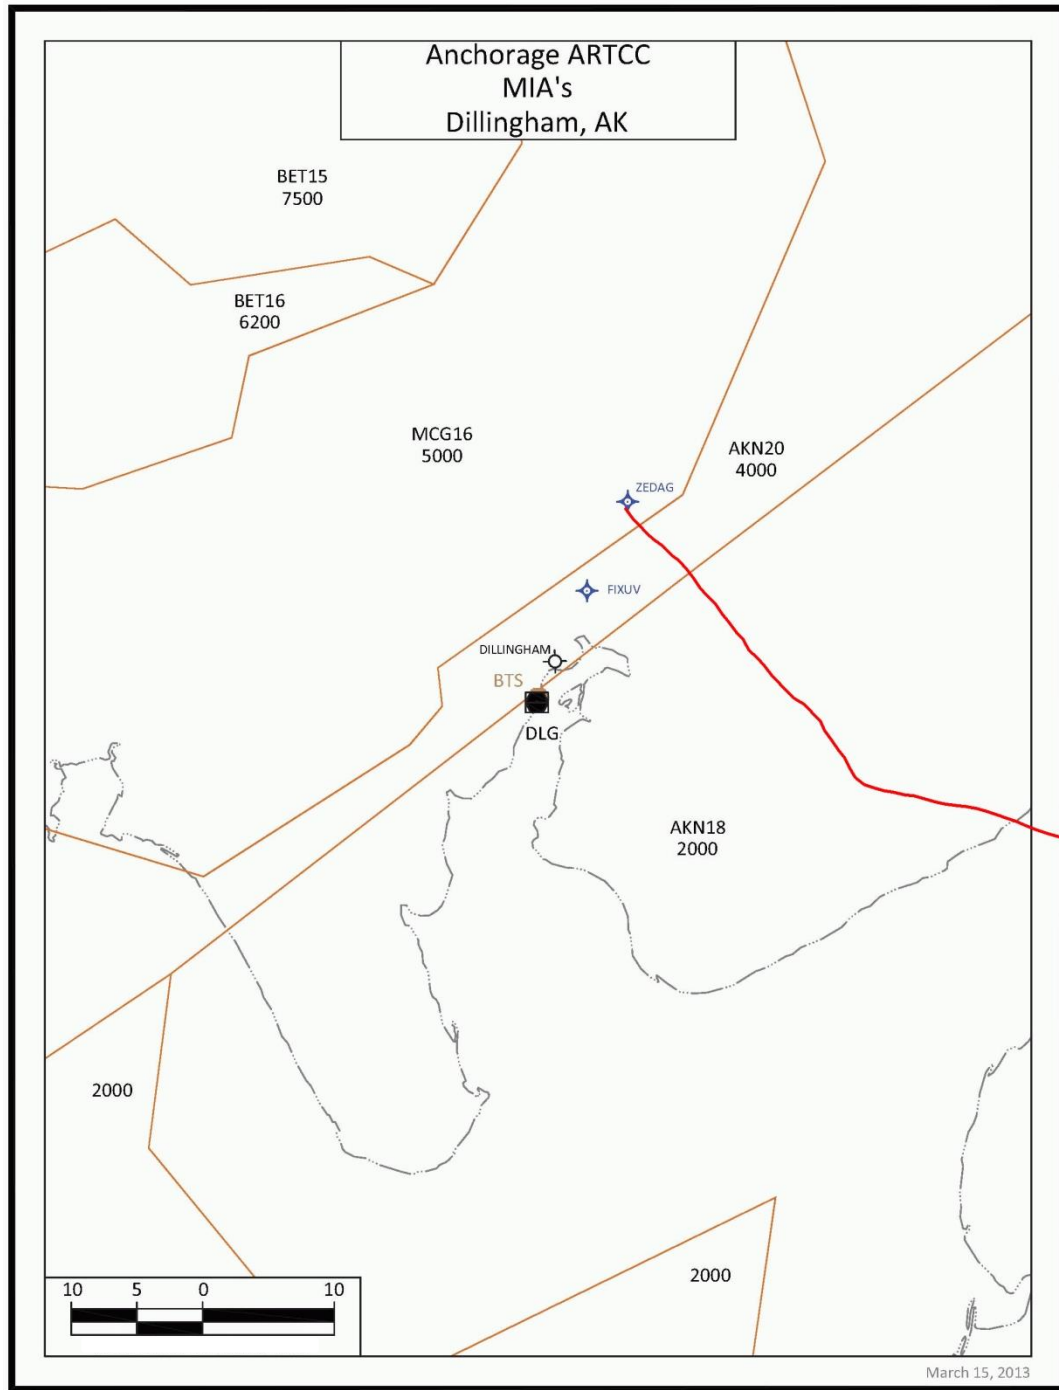
Figure 2 – Dillingham area minimum instrument altitude chart and flight track of AER51.

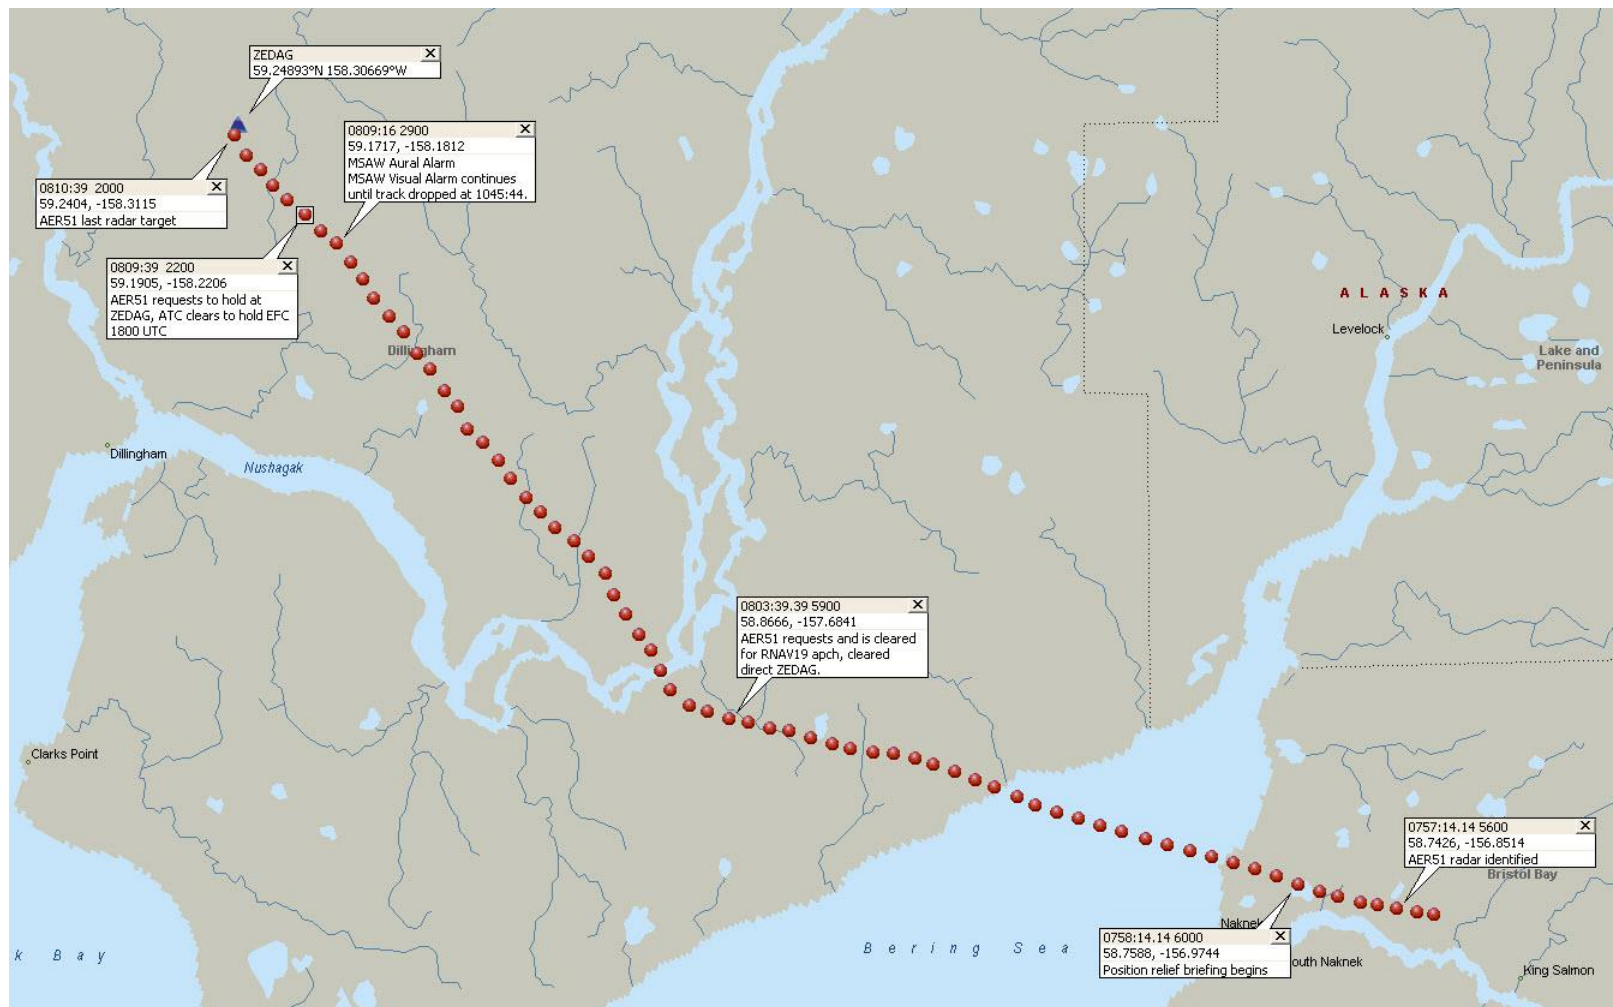
Review of recorded radar data showed that the aircraft's flight path caused a minimum safe altitude warning (MSAW) alert to the controller beginning with a one-second aural alarm at 0809:16 and a flashing "MSAW" indication in the aircraft's data block that continued from 0809:16 until the track was dropped at 1045:44.

Figure 3 – Overview of targets, times, and altitudes with selected communications.
One-second aural MSAW alert and continuing visual alert began at 0809:16.

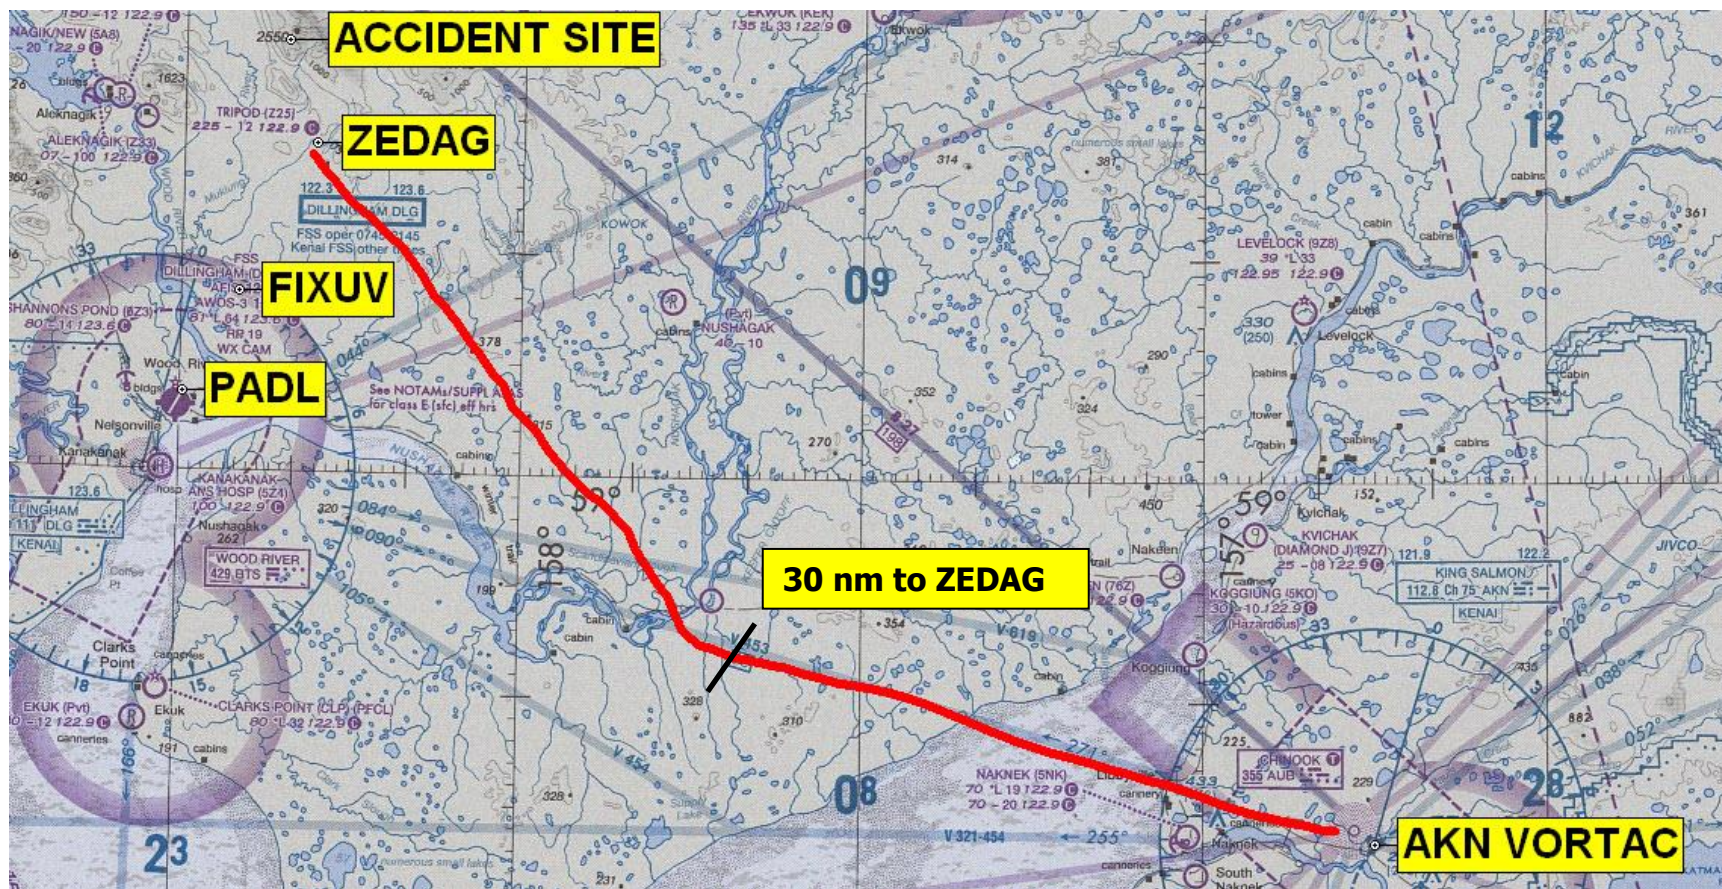
Figure 4 – AER51 ground track (red line) on the Kodiak sectional chart with RNAV GPS 19 approach fixes shown.

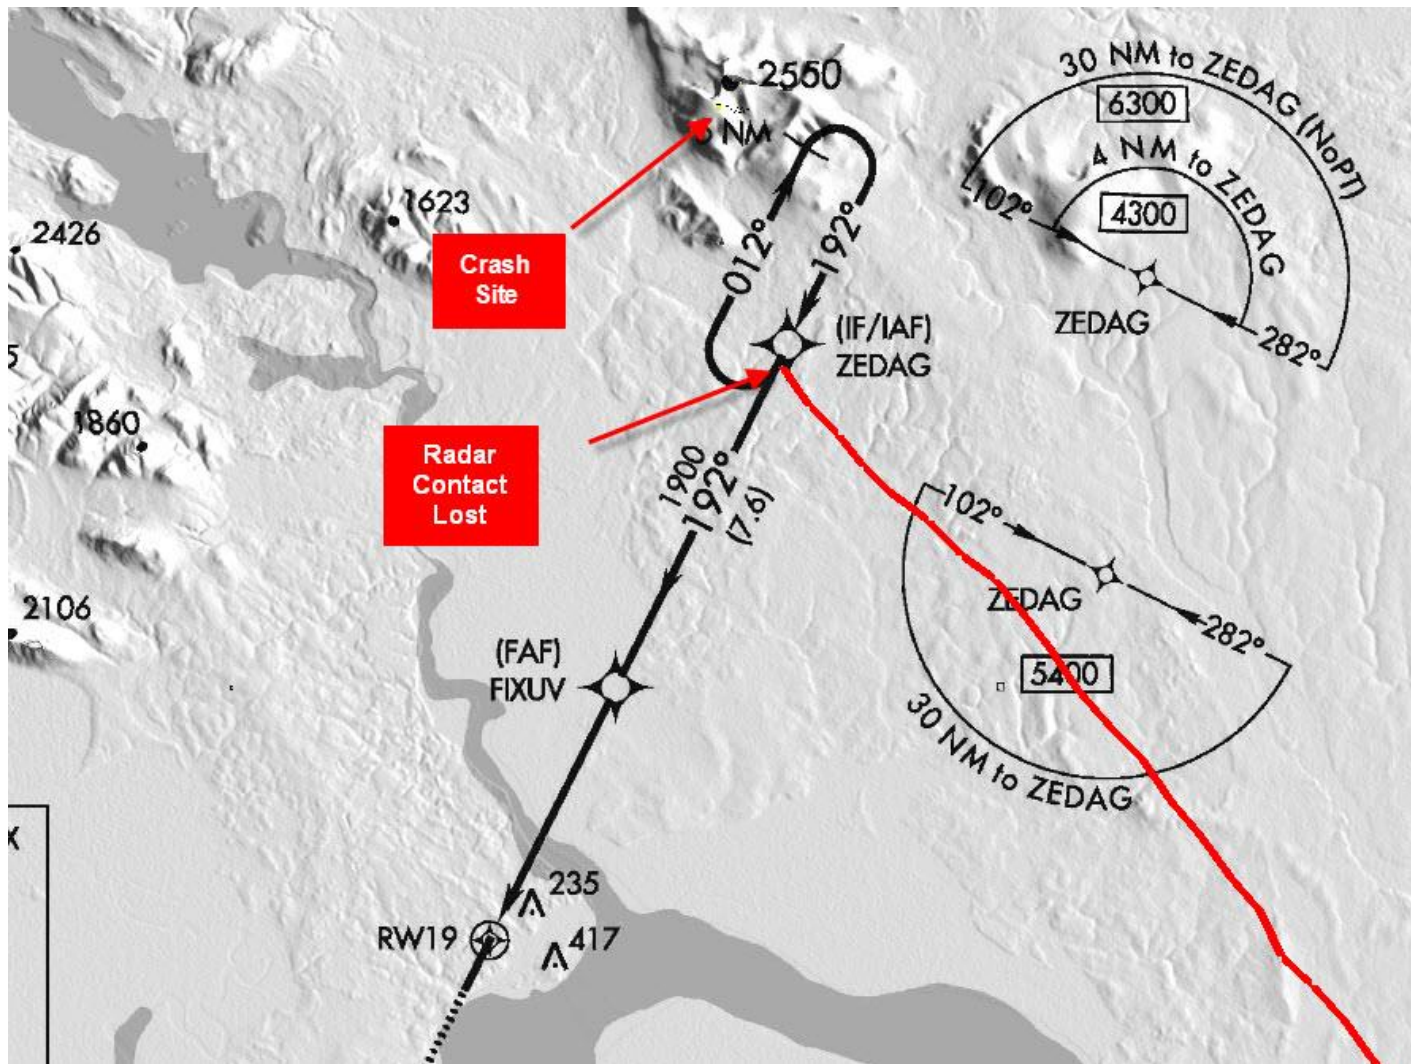
Figure 5 - Red line indicates the flight track of AER51 inbound from King Salmon. The aircraft's last reported altitude was 2,000 feet. The published holding altitude at Zedag was 4,300 feet.
